FINAL REPORT ON I470 WHEELING BRIDGE

HANGER CABLES AND CRACKS

IN TIE GIRDER DIAPHRAGMS

Fritz Engineering Laboratory Report No. 491-1(84)

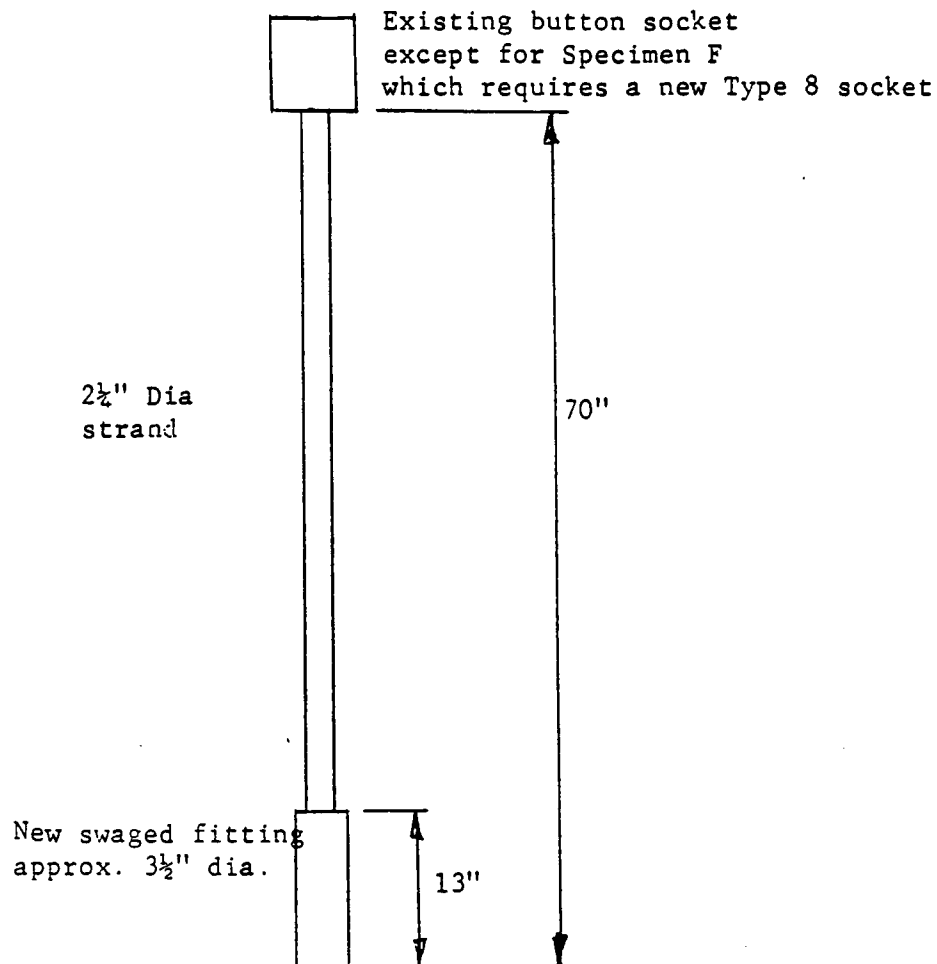
Fig. 1 Schematic and Designation of Test Specimens

Specimen	To be cut from cable	Location
A	7SW-Top	Tie end with 4 broken wires
B	7NW-Top	End with broken wires
C	5'NW-Bottom	End without broken wires
D *	8SE-Bottom	Tie end with broken wires
E	8SE-Top	End without broken wires
F **	8SE	Center of cable

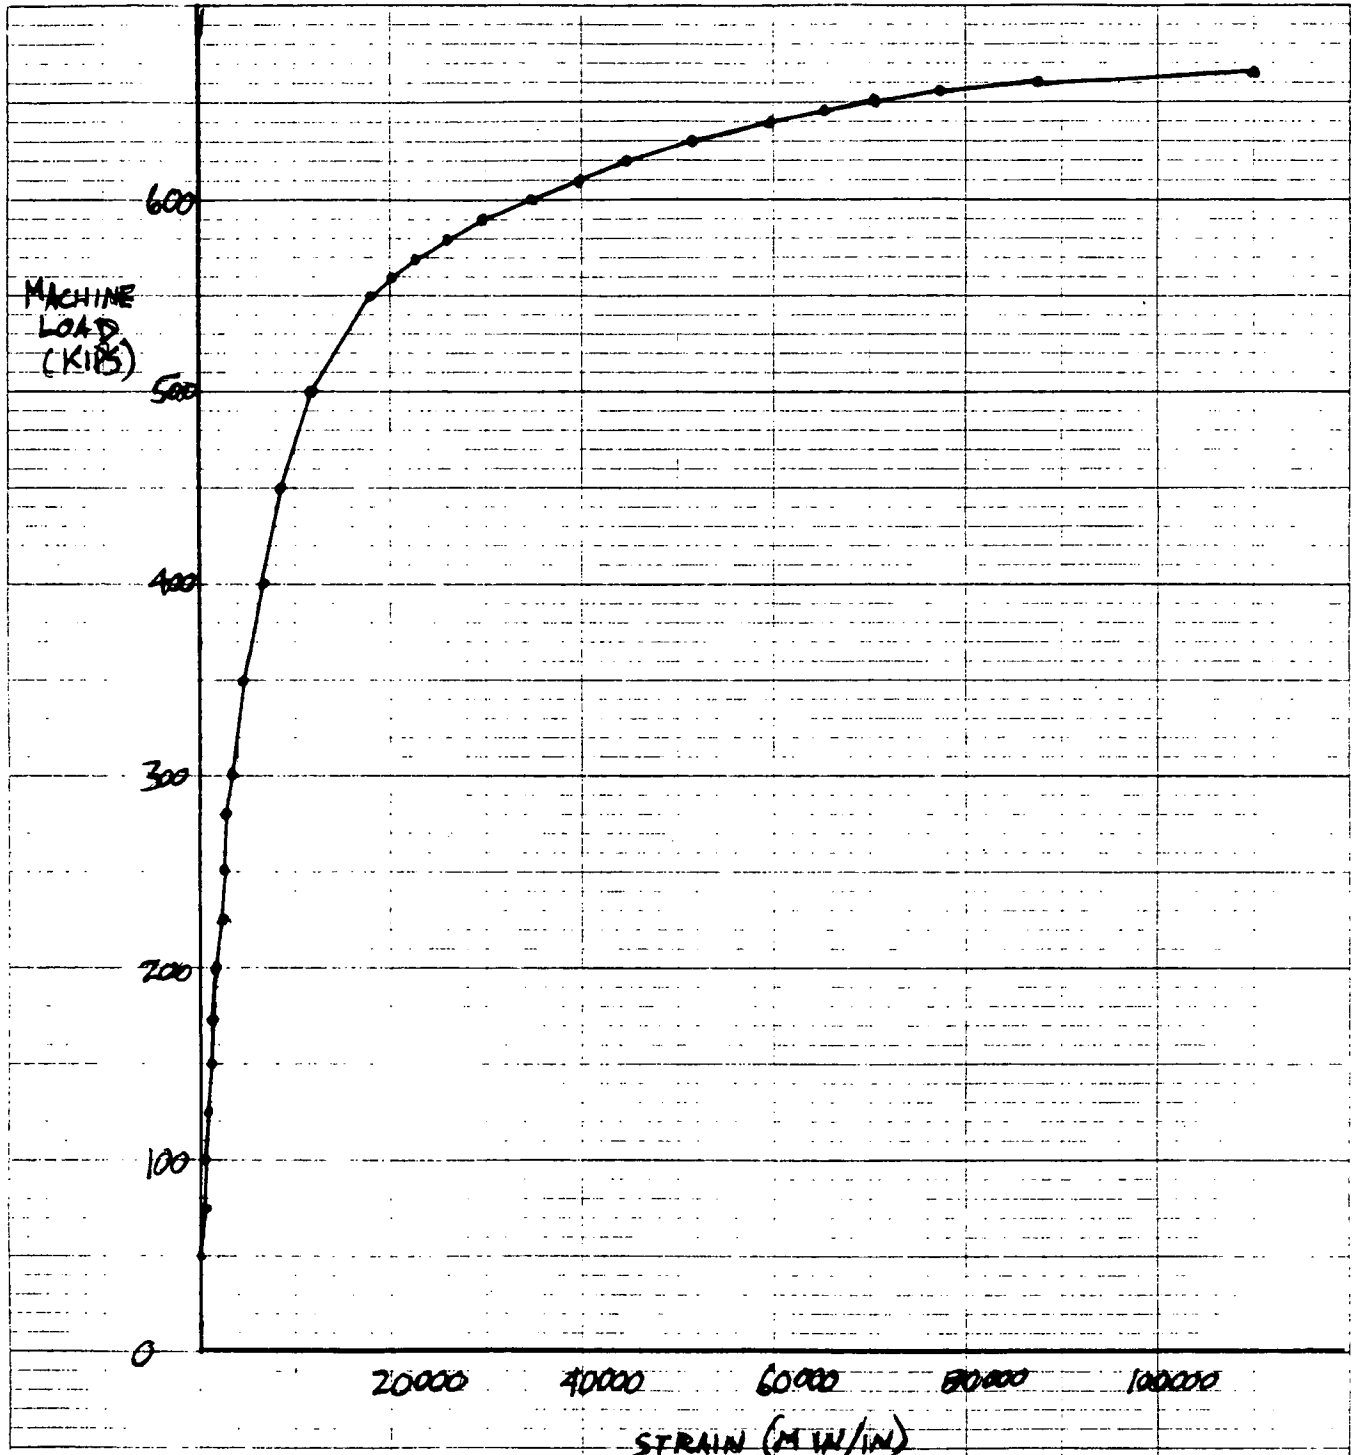
Fig. 20 Load-Strain Curve for Tensile Specimen

The load strain response is plotted in Fig. 20. The elastic modulus between the 50 kip and 280 kip load levels was calculated to be 26,900 ksi.

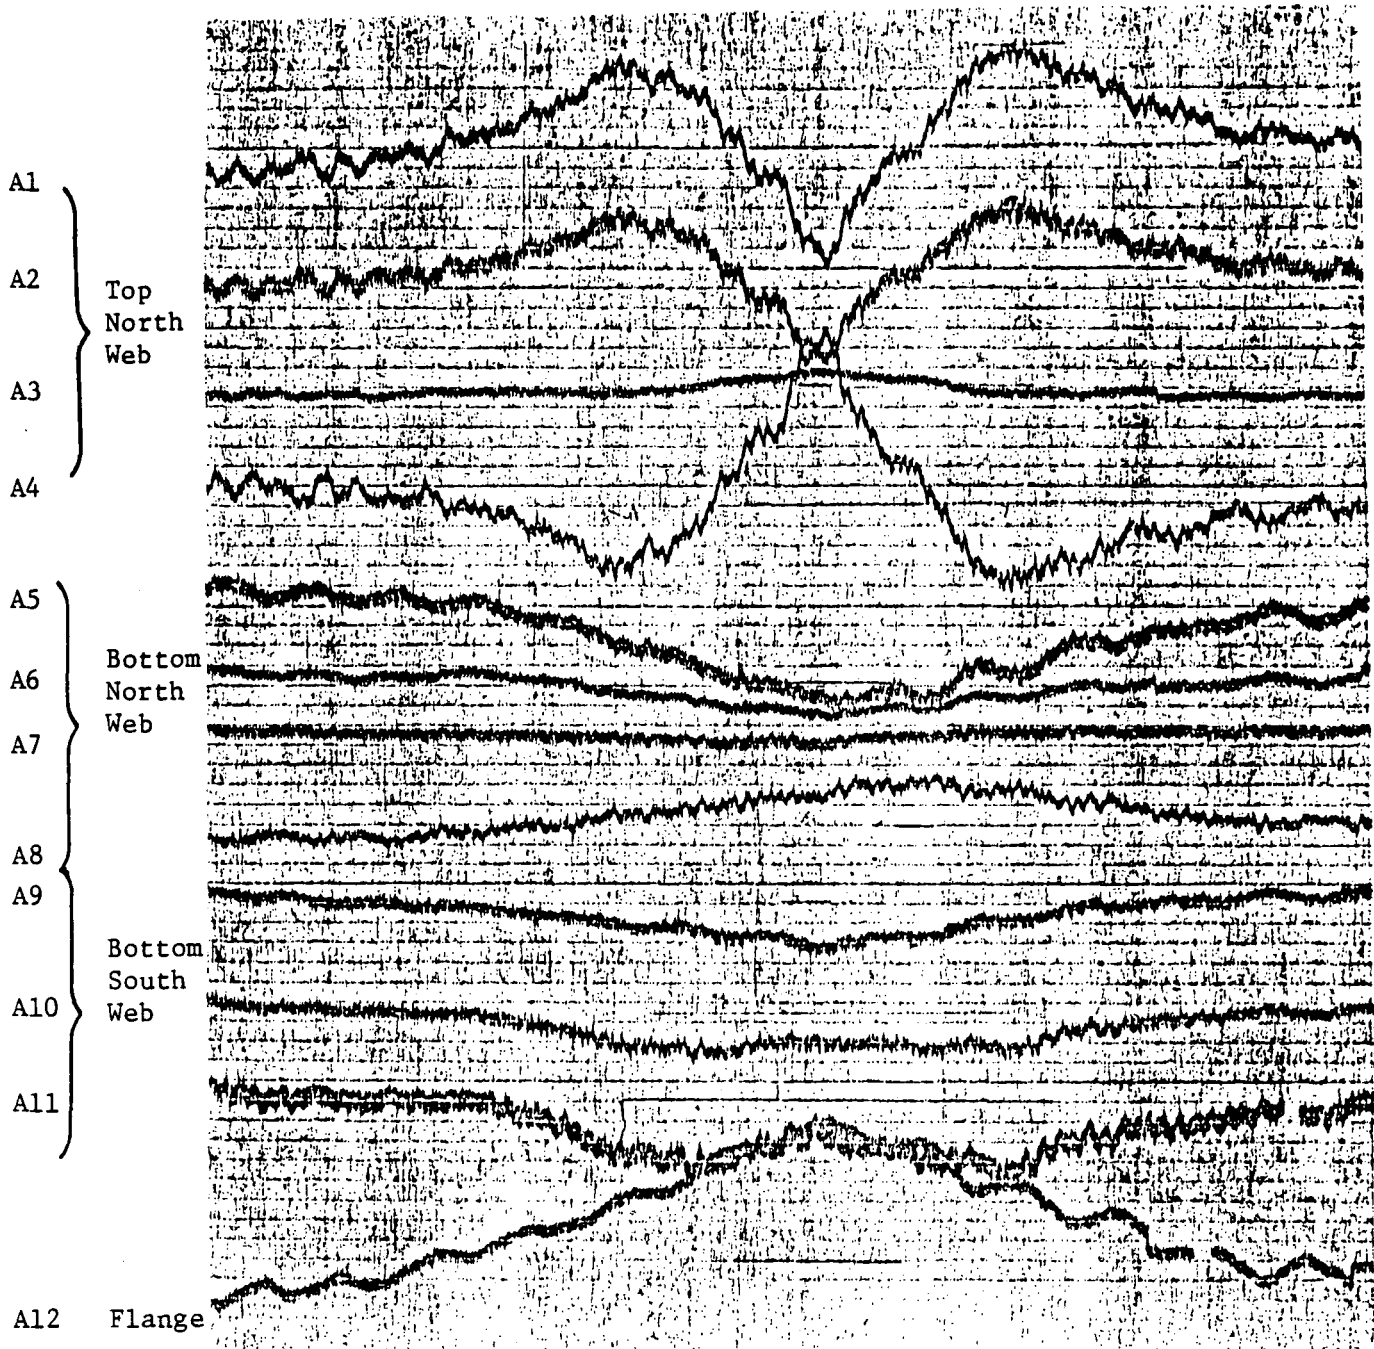
Fig. 42 Strain-Time Response Run 18 (WB) Panel Point 8

In general, the strain measurement - time records show that a large response occurs as the vehicles cross the floor beam at the gaged locations, as can be seen in Figs. 42 and 43. This response is characteristic of both the web gap regions and the diaphragm. In addition, the records also show that each truck produced one major stress cycle. It is also evident that all gages showed some degree of stress reversal.

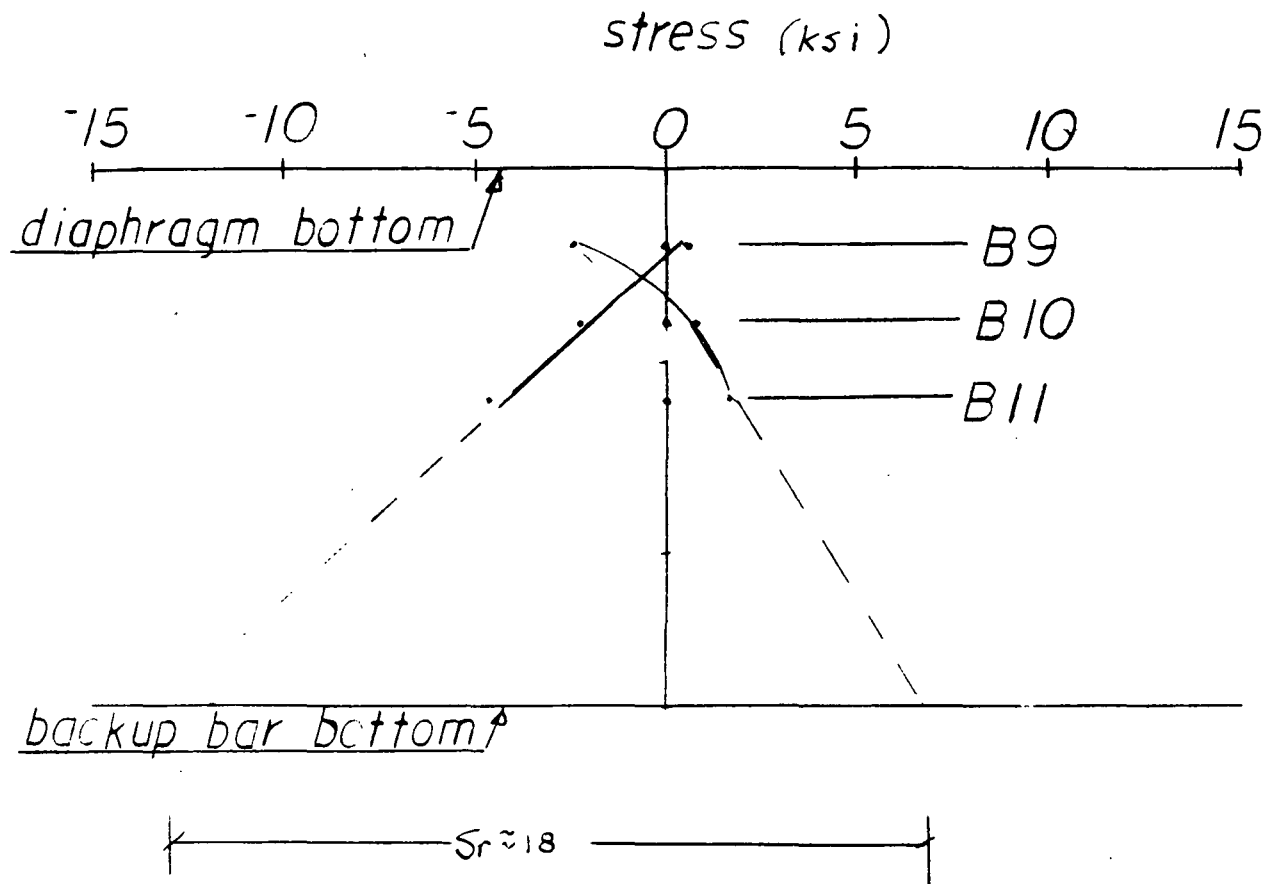
Fig. 52 Web Gap Stress Gradient in Region Adjacent to
Bottom Flange - Inside Web Panel Point 4'

From the strain measurement records, gradients in the web gaps at the maximum and minimum response during the stress cycle were constructed. Typical gradients are provided in Figs. 44 to 52. The difference between the two gradients represents the stress range. The results indicate that most of the web gaps are distorted in double curvature in the gap. This indicates that the web is being displaced out-of-plane relative to the flange. Lack of stiffness in the web gap due to the partial depth diaphragm is the primary reason for the high cyclic stresses.

The largest stress ranges were observed to occur at the bottom inside web gap at panel point 4' (floor beam side, see Fig. 52). A summary of the stress ranges observed during the eighteen test runs at gage B11 is given in Table 5. These gage measurements show that the largest stress ranges were observed when the trucks were traveling abreast. In addition, eastbound runs produced larger stress range values than the corresponding westbound runs. Truck speed had a negligible influence on the observed stress ranges.

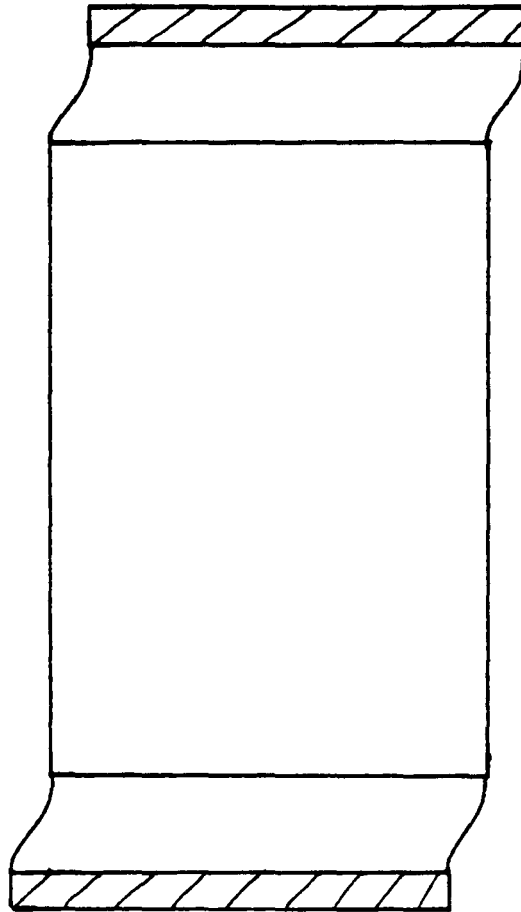
Fig. 53 Schematic of Distorted Cross-Section at Time T

Several displacement shapes were drawn that corresponded to the measured stress. Two distinct times were chosen from the strain measurement records. The distortions in the gaps were drawn qualitatively that corresponded to the measured gradients. Figures 53 and 54 show these relatively deformed shapes for two time intervals. The measurements and displaced shapes indicate that the floor beam end restraint moment is reversed, as would be expected from the deformed shapes shown schematically in Fig. 55. To evaluate the out-of-plane bending, the stress gradients were extrapolated to the end of the diaphragm welds and to the bottom of the backing bar. Table 4 gives a summary of the estimated stress ranges

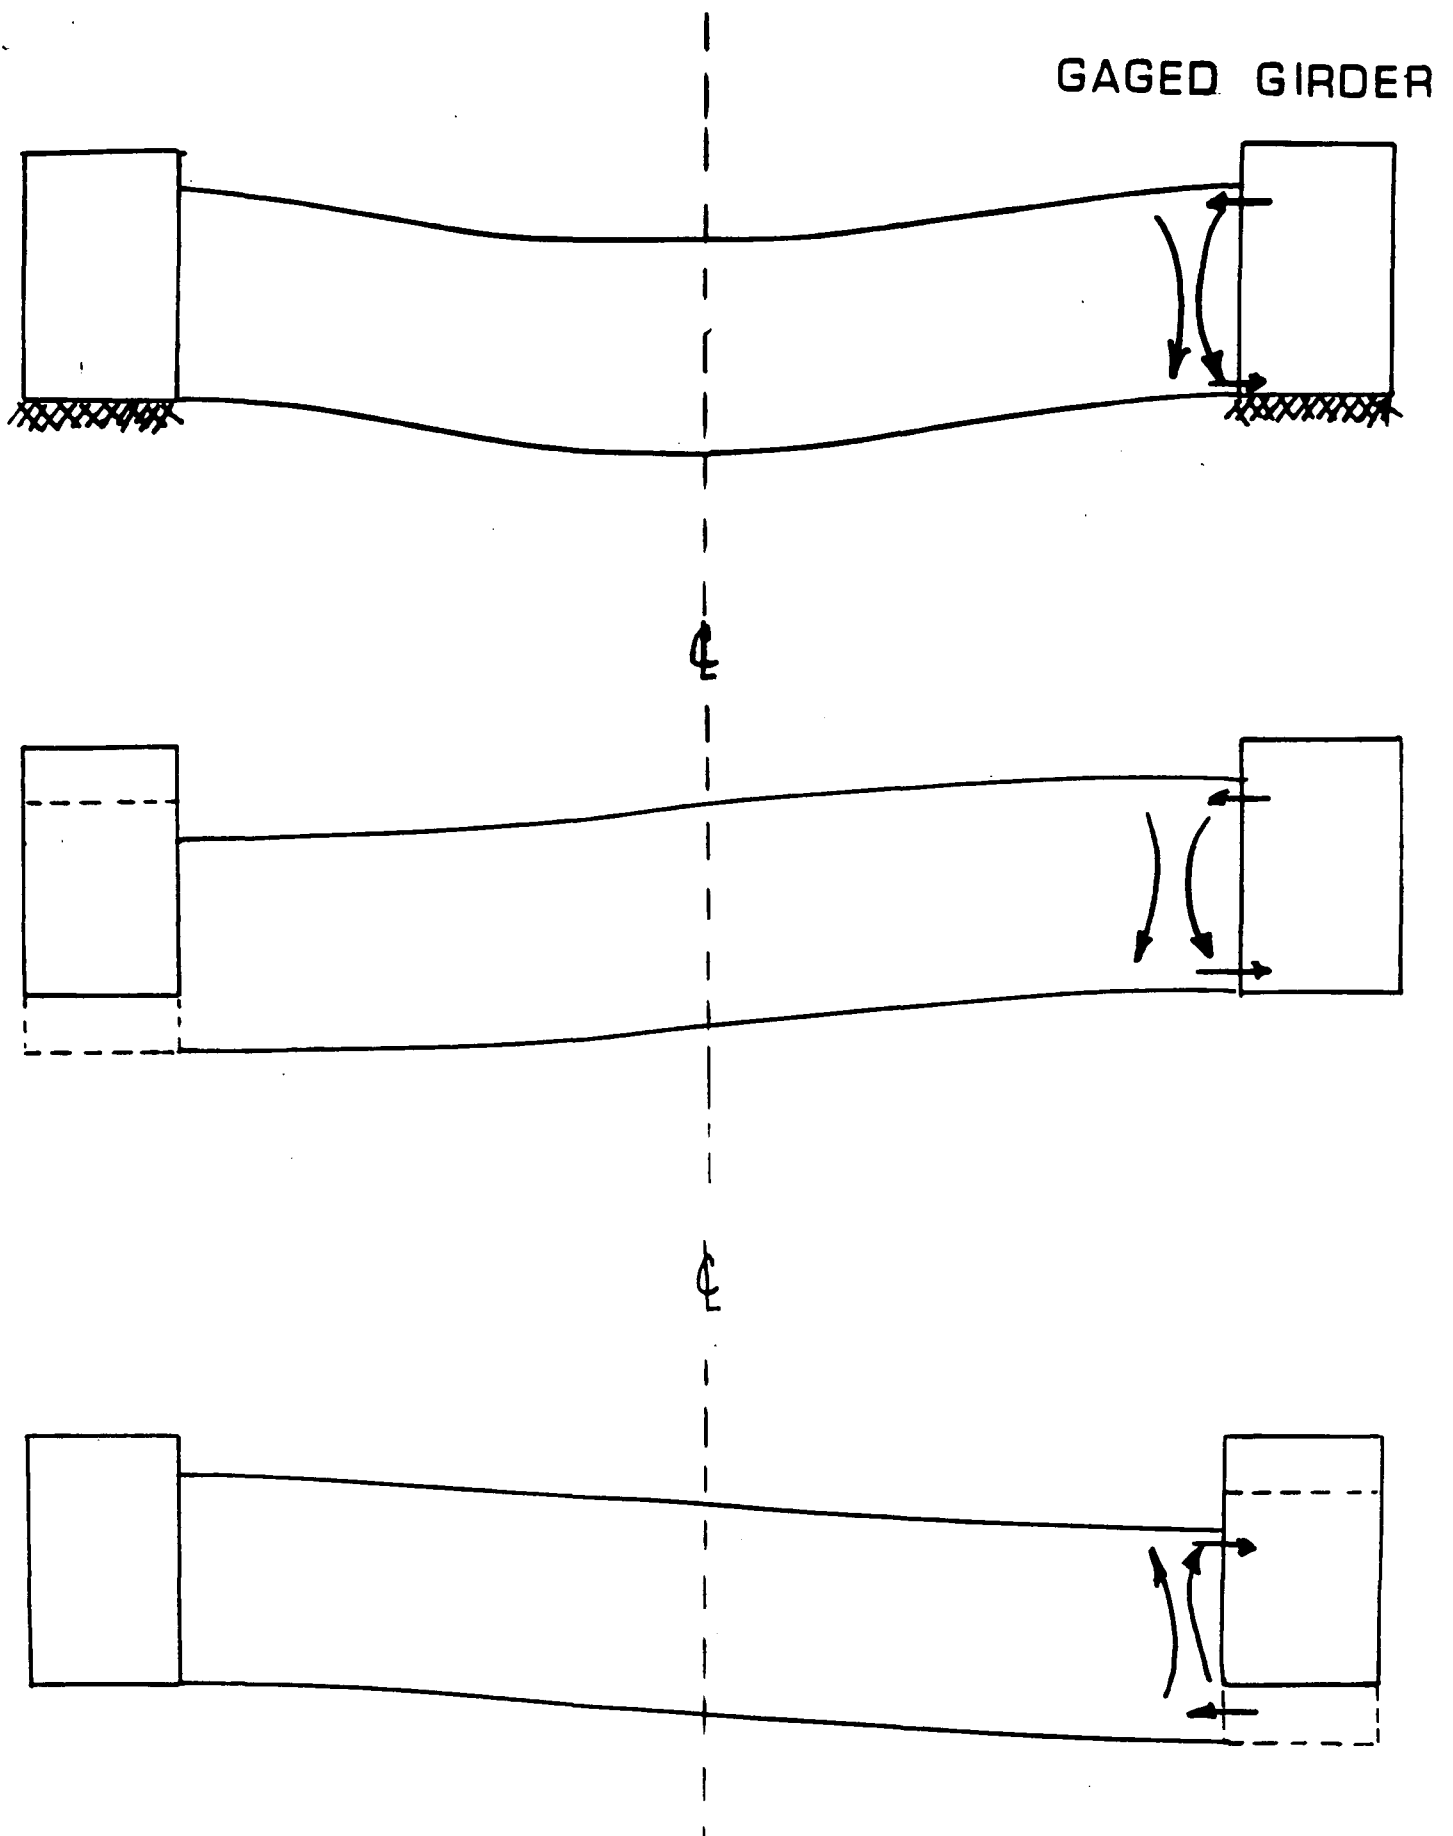
Fig. 55 Schematic Showing Possible Deformed Shapes of Floor Beam and Tie Girders

The largest stress ranges at panel point 4' were caused by vehicles traveling eastbound or away from the gaged location. The measurements suggest that the gap responses result from the double curvature bending of the floor beam and the relative displacement between the two tie girders, as illustrated in Fig. 55. The double curvature occurs because the floor beam is loaded through the bridge deck and stringers. Bending is also developed due to the relative displacement between the two tie girders. The displacement is due to the truck(s) traveling on one side of the bridge centerline or the other. With the trucks traveling eastbound, the

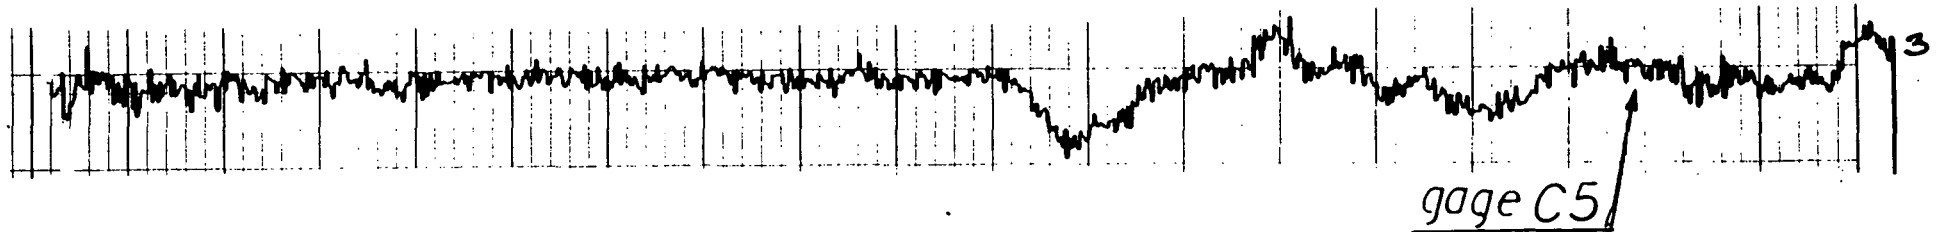
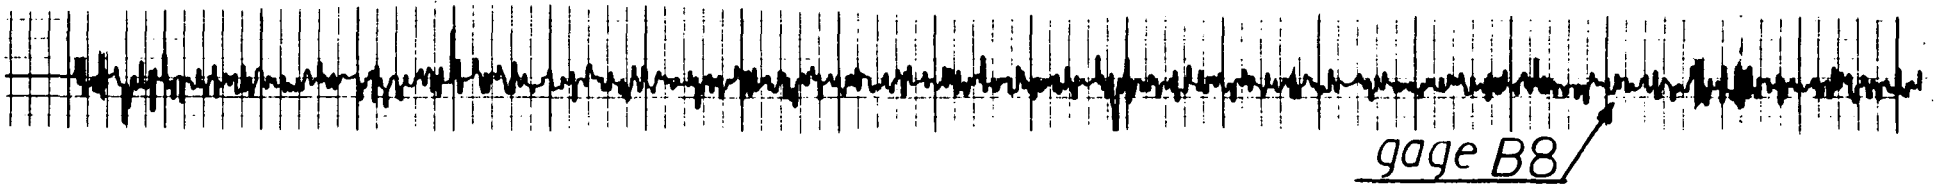
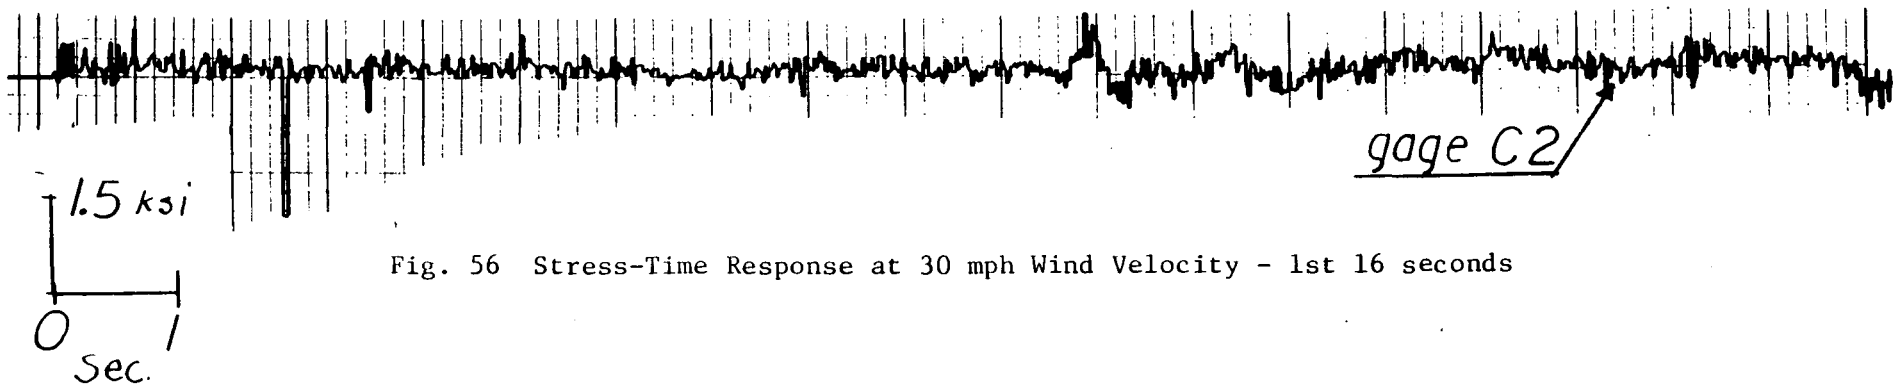
Fig. 56 Stress-Time Response at 30 mph Wind Velocity - 1st 16 seconds

At the higher wind velocities, an aeroelastic response was observed. Figures 56 and 57 show the response observed during the first 32 sec. interval when the wind velocity reached 30 mph. At the end of the initial 16 sec. (Fig. 56) interval, an oscillation started to develop that continued on during most of the next 16 sec. period (see Fig. 57). Vehicles crossing the span obviously interfered with the response. The frequency

of oscillation was about 1.5 Hz. The magnitude of the gage responses in Figs. 56 and 57 is about equal to half the response observed during the test runs summarized in Tables 5 and 6.

The results observed in Figs. 56 to 61 indicate that significant cyclic stresses could be developed as the tie girders oscillated. The cyclic stress occurred at a frequency of 1.5 Hz. Hence, each hour of such response would accumulate 5400 stress cycles in the web gap and welded connection.

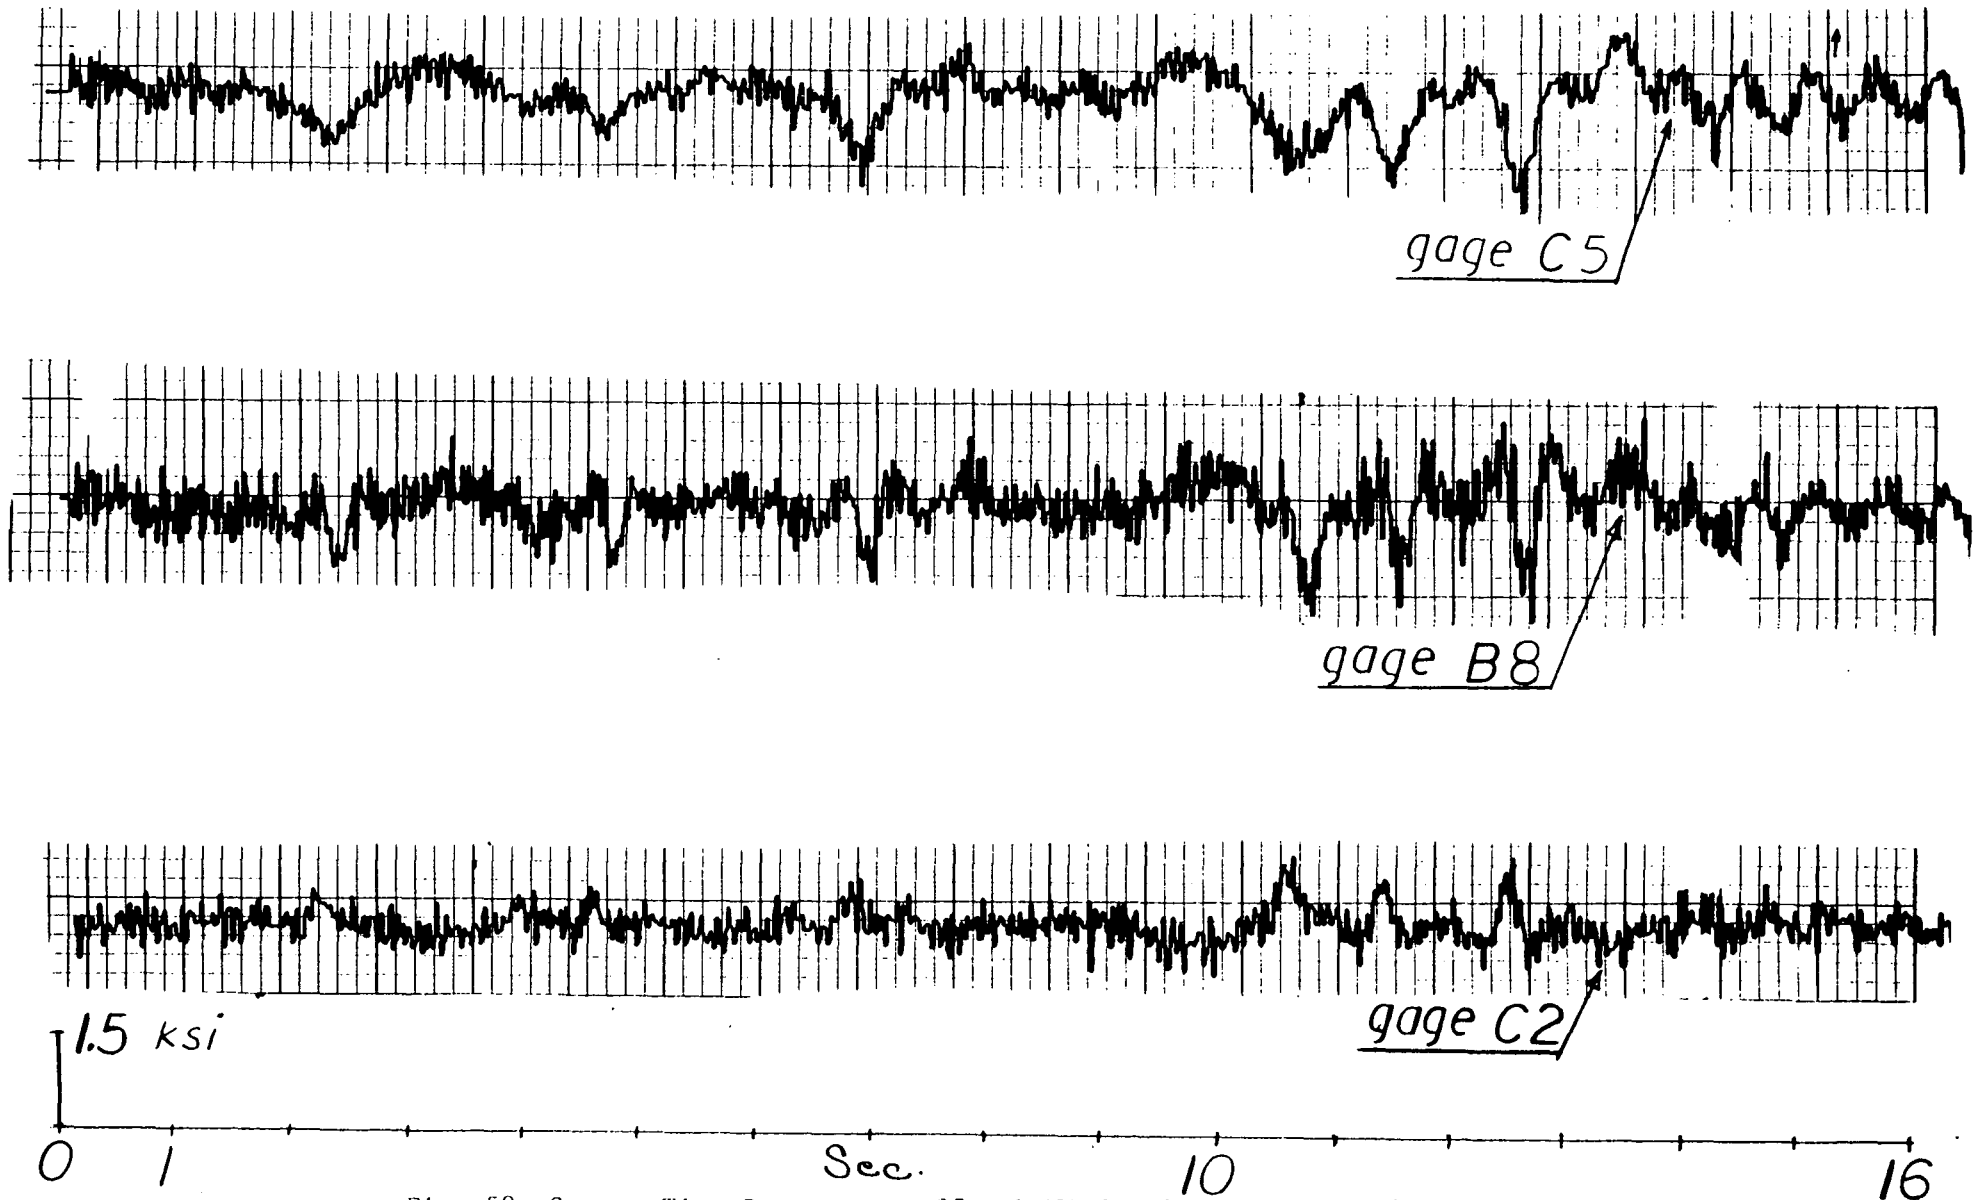
Fig. 58 Stress-Time Response at 35 mph Wind Velocity - 1st 16 seconds

When the wind gage was set to 35 mph, the response observed during the initial 32 sec. period is shown in Figs. 58 and 59. All three gages show that an oscillation develops after eight seconds that is larger in magnitude, but is dampened shortly after eighteen seconds. It appears that the wind velocity decreased abruptly, although vehicle crossings may have also had an effect. Once again the frequency of oscillation was about 1.5 Hz.

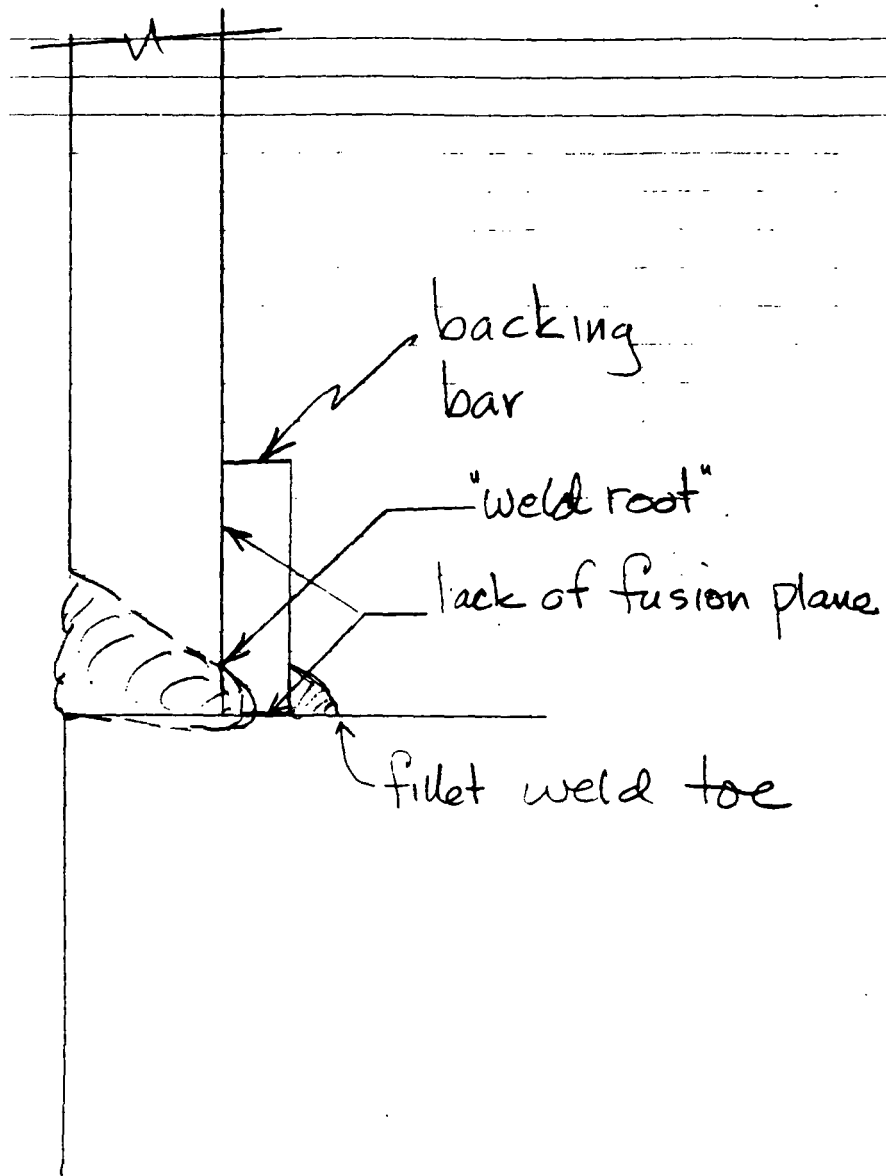
Fig. 63 Schematic of Box Corner Weld and Backing Bar
Showing Lack of Fusion Planes

The web - flange weld fused into a backing bar, as shown schematically in Fig. 63. Web gap bending stresses can result in fatigue crack growth from the weld root (see Fig. 63), and from the lack of fusion between the backing bar and flange.

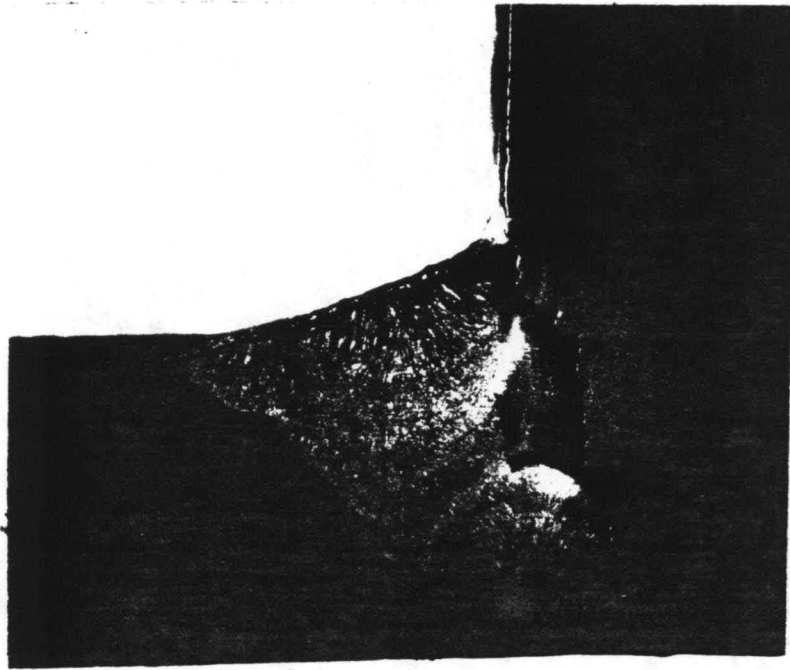
Fig. 70 Macroscopic Etched Section of Sample 1

The results of this examination are seen in Figs. 70 through 73. Figures 70 and 71 show the overall configuration of the weld joints in the hanger support angle with the location of the cracks indicated. The welds are seen to be multipass full penetration ones, and the cracks are seen to initiate (based on crack width) at the toe of the weld inside the angle and extend initially along the fusion line (but just inside the heat affected zone).

The crack moves from this weld zone to the plate itself (in Figs. 70 and 71, the vertical leg) and extended in a delaminating mode to the heat affected zone of the weld on the outside of the angle. At this location it follows the heat affected zone close to the fusion line until it comes to the irregular fusion zone of one or more final or "cap" passes on the outside weld where it terminates.
